FEEDER SURVEY IN KARNATAKA

Key Observations

Center for Study of Science, Technology and Policy (CSTEP)

May, 2019

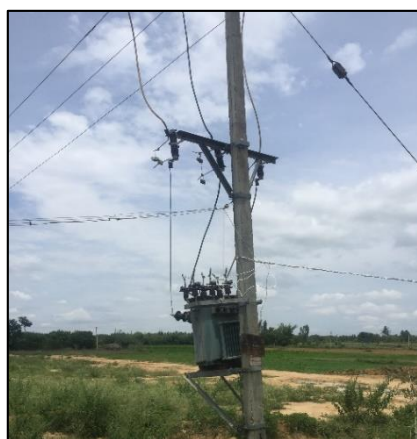
The survey showed that 28% (206) of the total DTs are not metered (Figure 5 and Figure 6). Of the 542 metered DTs, 104 meters were found defective, with defects such as meter not recording (MNR) due to loose connections, meter burnt out (MBO), and meters with partial display (Figure 7 and Figure 8).

Figure 5: DT without meter (1)

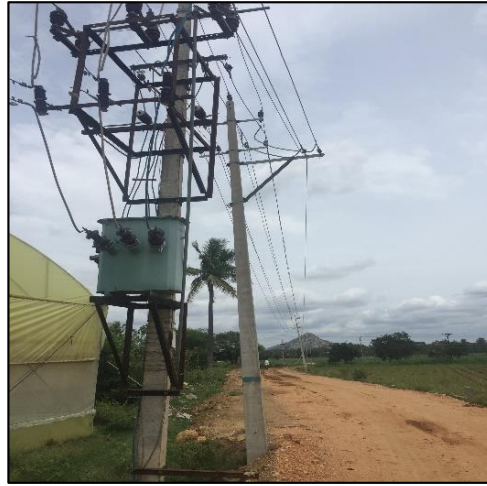
Figure 6: DT without meter (2)

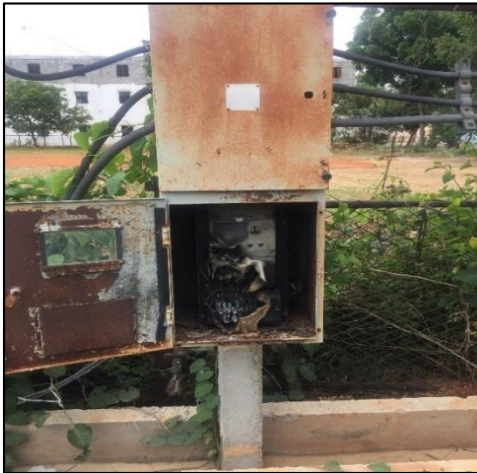
Figure 7: DT Meter burnt out (MBO)

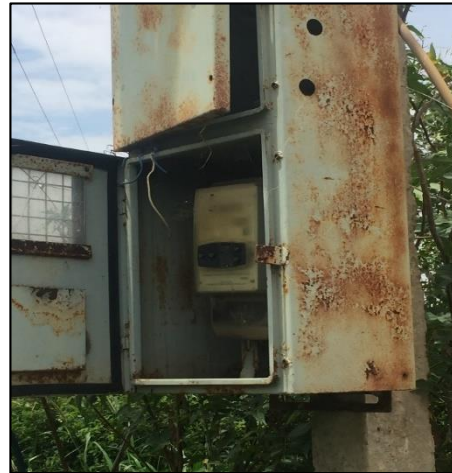
Figure 8: Meter not connected

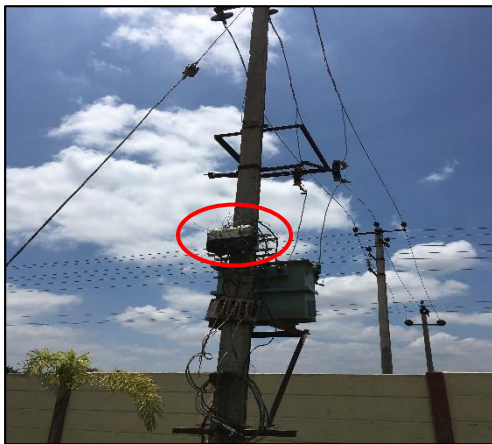
During the field survey, it was found that 21% (112) of the DT meters are inaccessible due to huge bushes and shrubs growing close to the transformer, meters being placed too high and thus unreachable (Figure 9 and Figure 10), etc., making it difficult to record the readings.

Figure 9: DT meter placed high

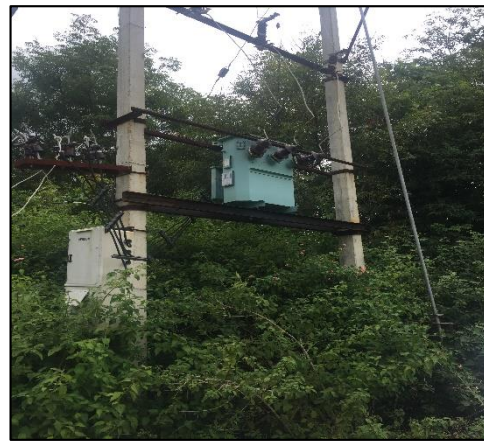
Figure 10: DT location inaccessible

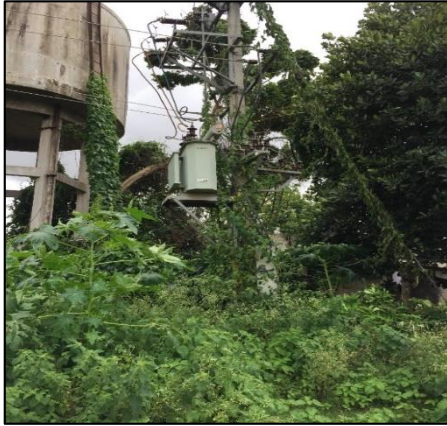
- a) *Trees and bushes on transformers, poles, and overhead lines:* Figure 11, Figure 12, and Figure 13 show plants and bushes growing near a transformer, poles, and overhead electrical lines. Overhead lines are usually not protected by insulation, so anything coming in contact with or even close to an overhead line would become a direct pathway for an electric current, which could result in electrocution, injuries, and power outages. The survey revealed that 65% (13/20) of the feeders had issues relating to poor maintenance, which could lead to safety and reliability problems. Such issues were not observed in the remaining 35% feeders.

Figure 11: Transformer covered with trees and creepers

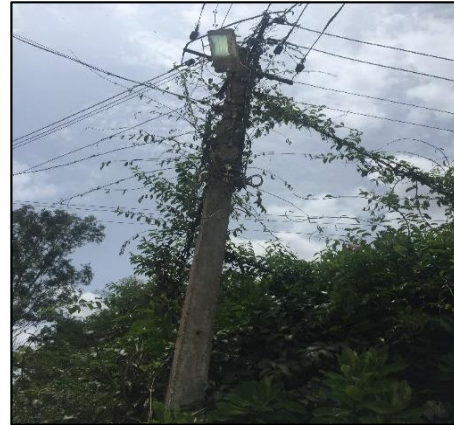
Figure 12: Overhead lines covered with bushes

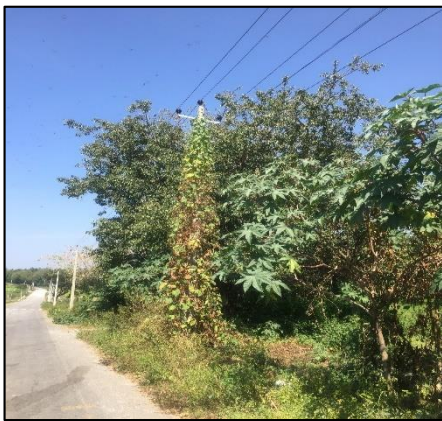
Figure 13: Poles covered with bushes

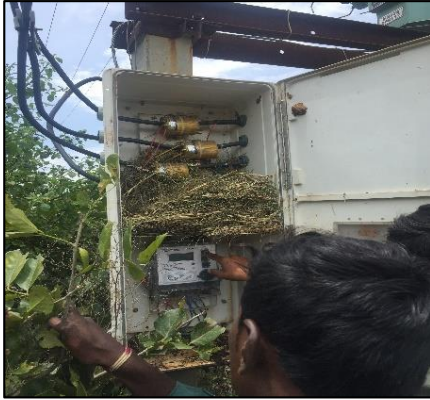
b) *Poor maintenance of DT meters:* Figure 14, Figure 15, Figure 16, and Figure 17 illustrate the poor conditions of both meters and current transformer (CT) boxes of DTs. It was observed that 40% (216/542) of DT meters were not well-maintained, with issues such as meter not connected and current transformer (CTs) burnt out. In a few cases, even the newly installed meters were infested with rats and birds' nests.

Figure 14: Poor condition of DT meter

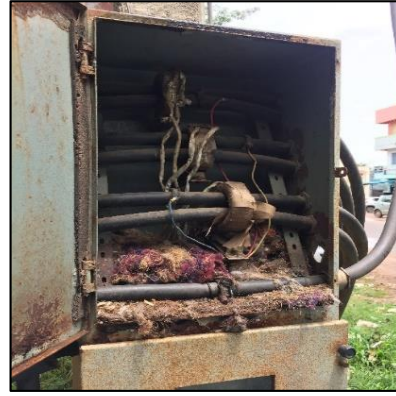
Figure 15: Burnt out connection in CT box

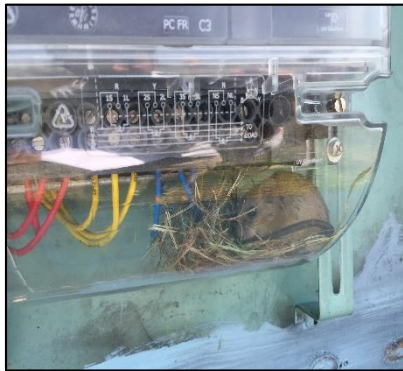
Figure 16: Rat inside the meter

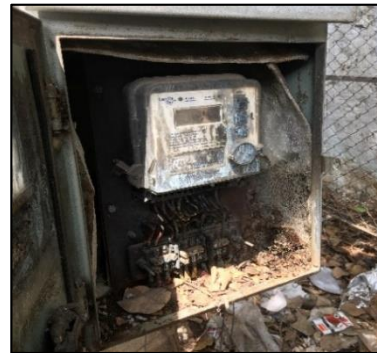
Figure 17: Poor condition of meter box and faulty meter

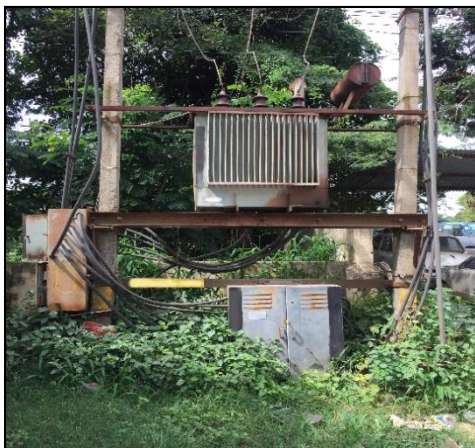
c) *Poor maintenance of distribution network infrastructure:* Inadequate network maintenance leads to additional cost for DISCOMs, due to the frequent replacement of assets; it is also one of the reasons for high technical losses in the system. As per Central Electricity Authority (CEA) technical standards for construction of electrical plants and electric lines (CEA, 2018), a single-phase DT with a capacity of 25 KVA should be installed on a single-pole / 2-pole structure and 3 Phase DTs up to a capacity of 500 KVA on 2-pole (H-pole) or 4-pole structures or on a plinth. The two-pole structure (H-type pole configuration) helps locate DTs at a certain minimum height from the ground level to meet the ground clearance (around 3 meters by 2 meters (on ground) around the H-pole structure). This area should be provided with suitable fencing and lockable doors to prevent unauthorised access to the distribution box.

Figure 18: DT control box placed on ground

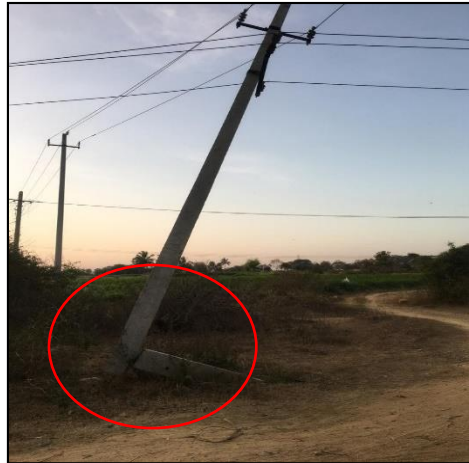
Figure 19: Broken pole

Figure 19 shows a broken pole that could lead to long hours of supply interruption and also acts as a safety hazard.

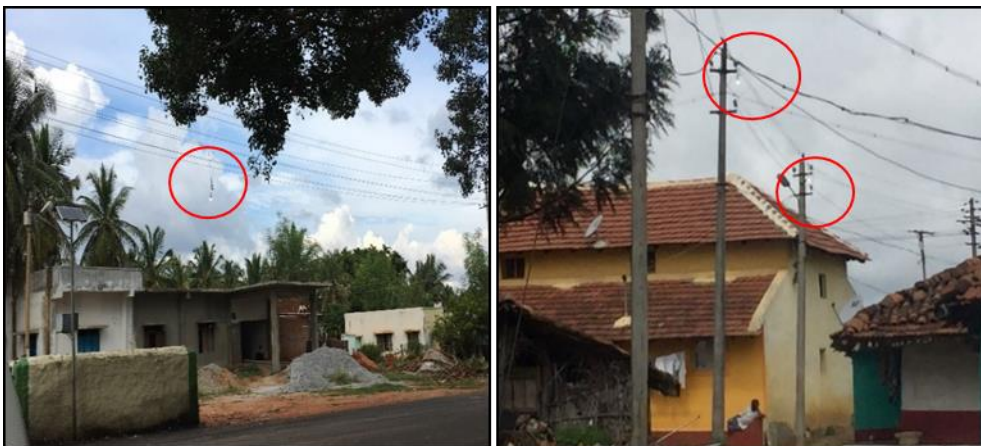
- d) *Absence of street-light meters:* As per a Forum of Regulators (FOR) report (Forum of Regulators (FOR), 2009), all street lights were to be installed with meters to accurately assess their consumption. Further, in 2012, Karnataka Electricity Regulatory Commission (KERC) issued directions to all Karnataka DISCOMs to install electronic timer switches for street-lights so as to switch them 'on or off' at the required timings. However, of the 90 villages visited during the field survey, we saw that 36 villages were not yet installed with street-light meters and timer switches. In a few villages, street lights were hooked up in the middle of the line and switched on during the day as well (Figure 20). In the absence of control switches, it leads to unaccounted energy consumption and loss of revenue for DISCOMs.

Figure 20: Unmetered street lights

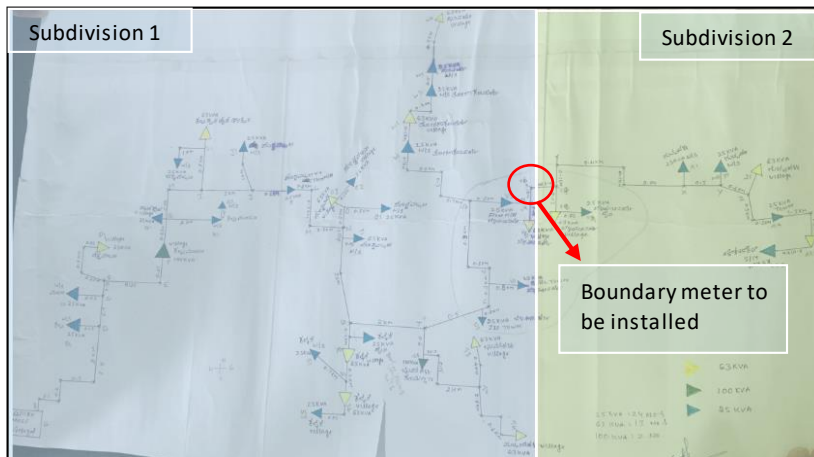
As per the FOR report (Forum of Regulators (FOR), 2009), boundary meters should be installed at every transition point for 11 kV feeders. The field survey revealed that Feeder-17 was supplying energy to more than one subdivision (Figure 21). In the absence of boundary meters, the amount of energy exported to each subdivision by the same feeder cannot be determined. This would lead to double accounting of energy exported

by the feeder and inaccurate apportionment of energy between subdivisions having the same feeder.

Figure 21: SLD of a feeder supplying energy to two subdivisions

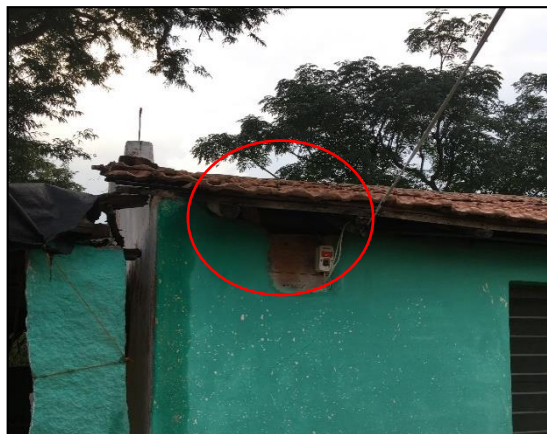
During the survey, we found that a few consumer installations were unmetered while drawing energy from the network through direct connections (Figure 22). This would lead to unaccounted energy consumption for DISCOMs, adding to their AT&C losses. Further, we observed that a large number of electromechanical meters are still in use in rural areas, which should be replaced by electronic meters.

Figure 22: Installation with direct connection (without meter)

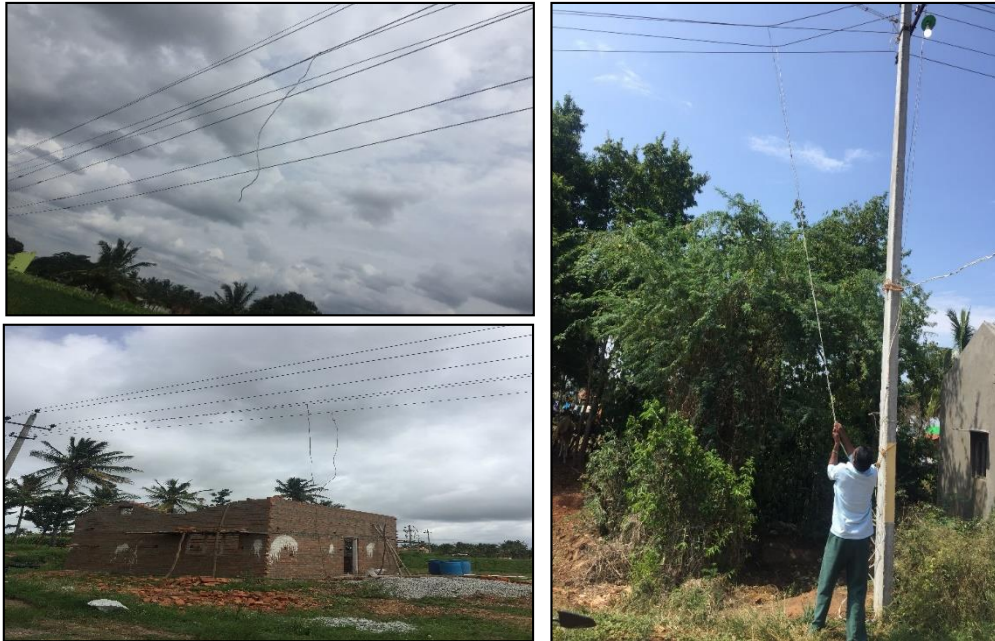
In a few cases, we found that consumers engage in theft and illegal connection/tapping of the LT lines. Most theft cases were observed in NJY feeders as compared to the urban feeders (Figure 23). Of the total surveyed feeders, one NJY feeder was found to be supplying energy to IP feeders. We also noticed that a few other NJY feeders were feeding the partial load of IP sets to avoid the overloading of the IP feeder. Figure 24 shows an IP set connected illegally to an NJY feeder.

Figure 23: Theft cases observed in various feeders

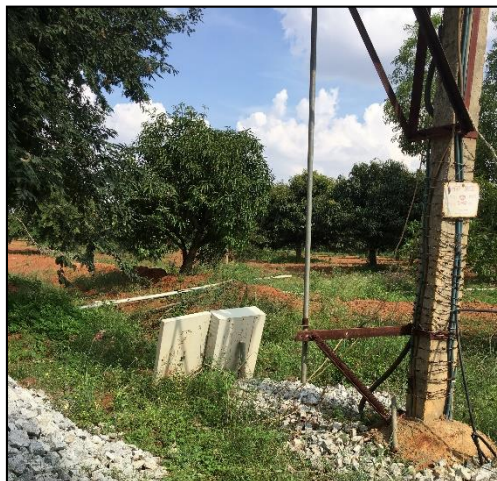
Figure 24: Illegal connection of IP set to NJY feeder
