## Study: BESCO transformers poorly maintained, can disrupt power supply

### POWER SUPPLY IN BENGALURU

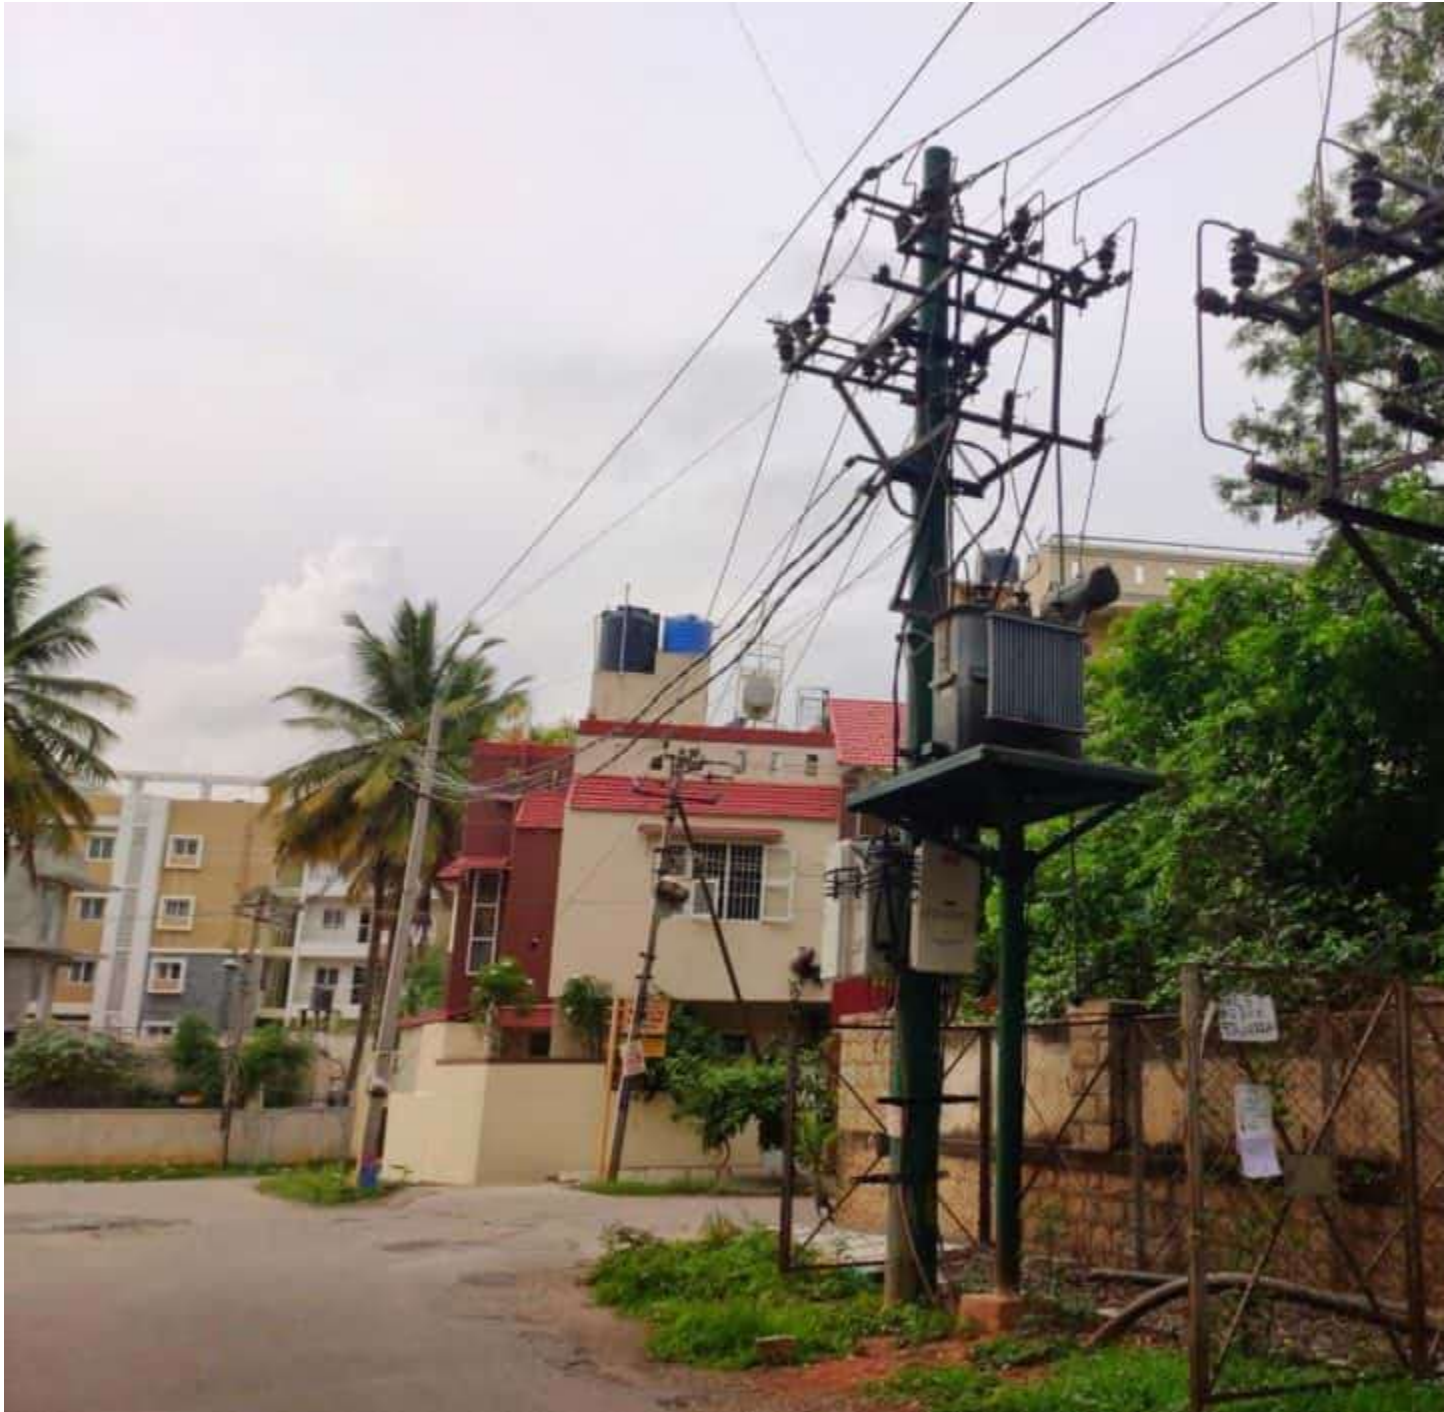
Due to poor maintenance and metering, transformers can get damaged frequently, causing power cuts. Pic: Ekta Sawant

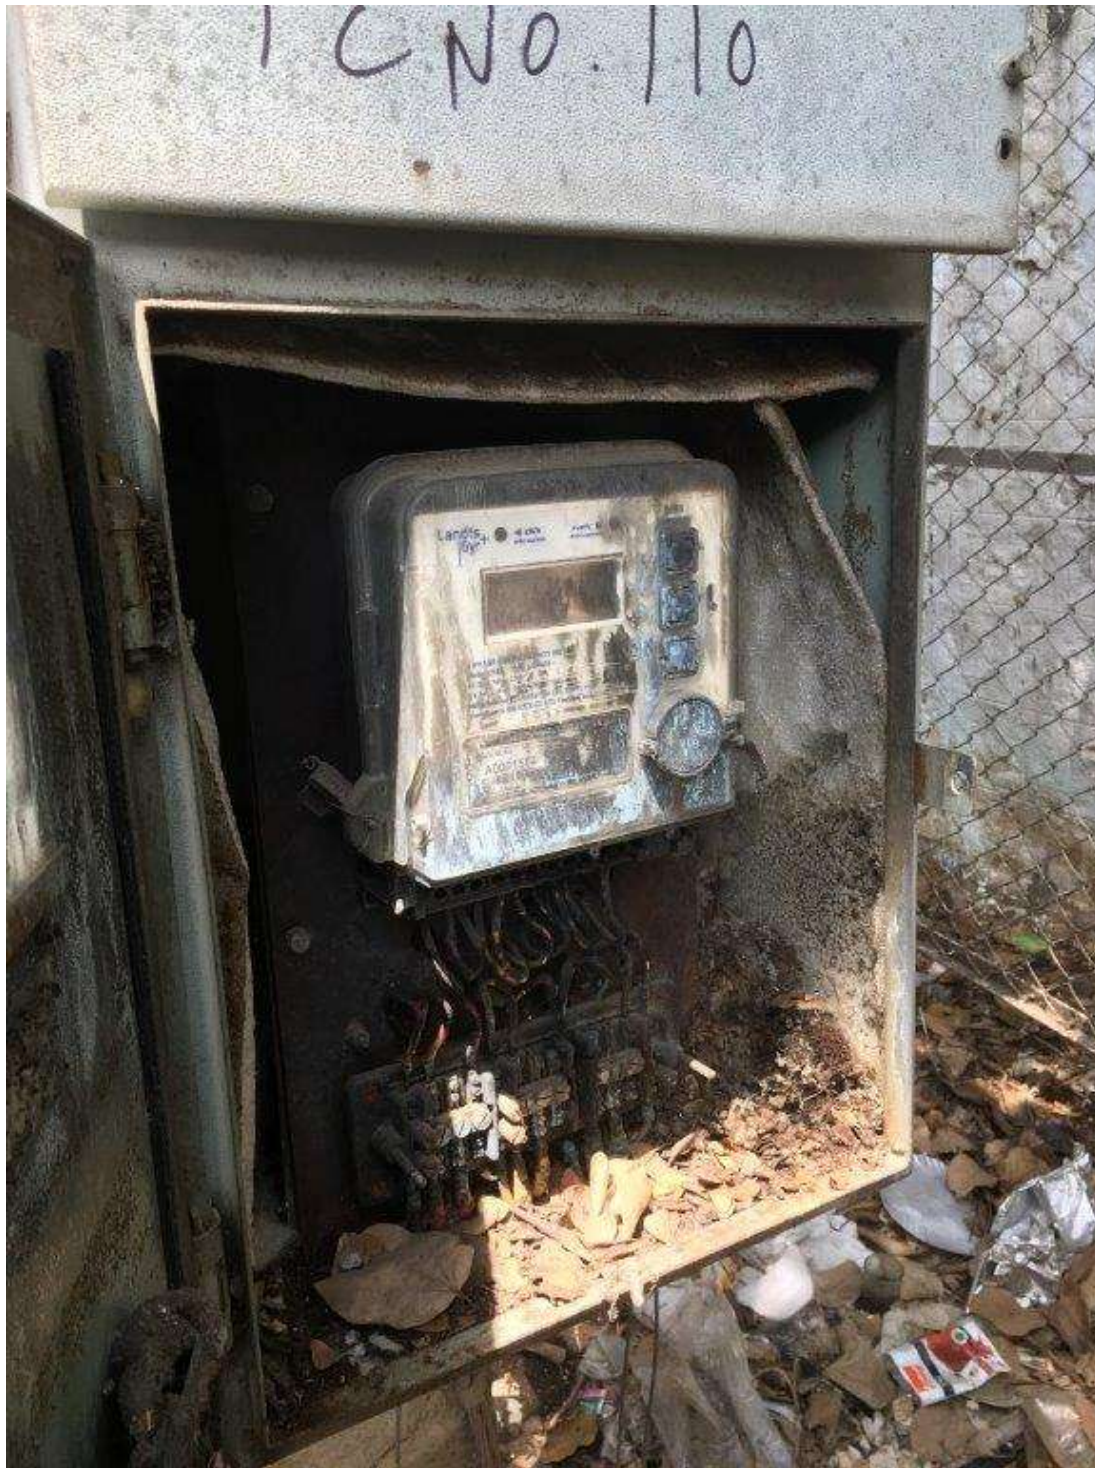
At CSTEP, we surveyed 707 transformers under BESCO which serves eight districts including Bengaluru Urban and Rural. The survey threw up some startling results. Of the examined transformers, 40% were unmetered. Even among the remaining metered transformers, 49% meters were either defective or inaccessible due to poor maintenance. These involved instances of meter burnt out, meter not recording, and meter reading not visible.

A burnt-out transformer meter. Pic Credit: Rishu Garg

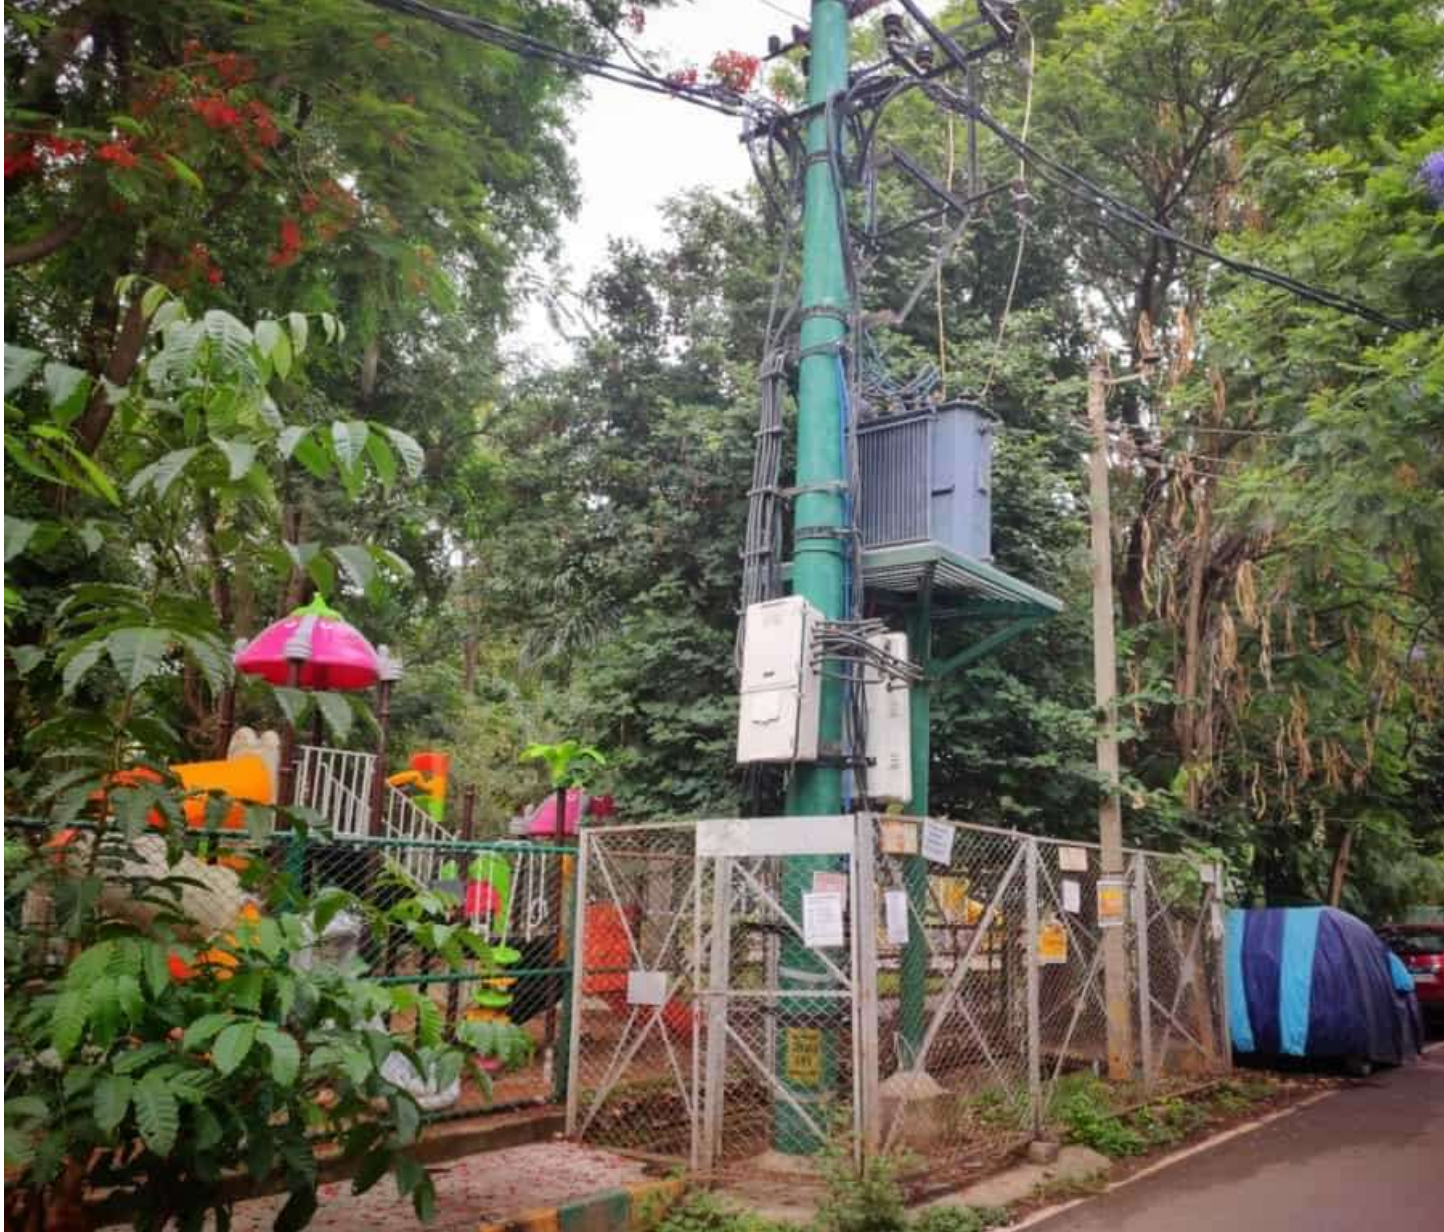
BESCOM doesn't have accurate data on the number of transformers in its jurisdiction. Pic: Ekta Sawant

A solution could be to identify and locate transformers using a geographical information system (GIS) mapping technique, and to create a profile for every transformer. This technique would also allow recording of details such as the transformer's capacity, number of consumers connected to each transformer, and the load.
